**Flood Control Project Maintenance  
Levee Inspections**

## Maintenance Issue Types Only, Levee Inspection Report By Mile - Spring 2019

### Lake County Watershed Protection District

Waterway	Bank	Unit Miles	Inspection Start/End	Inspector
Unit No. 01 Middle Creek	Left	3.35	04/11/2019 05/24/2019	Luz Dial

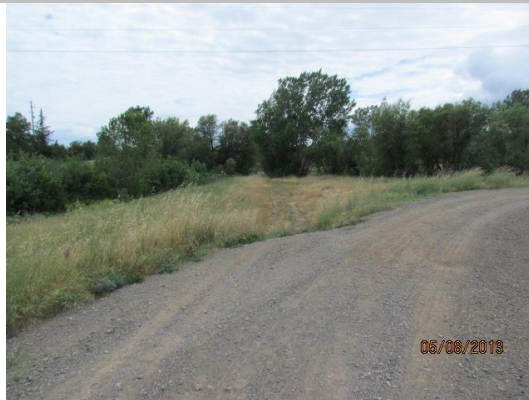
Photo 1 of 1 : SP\_2019\_NA0009\_3\_13\_20190411\_00007.jpg

View of the vehicle erosion along the waterside slope.

LM Start	2.29	Rating **	M	Issue No.	13
LM End	2.29	Issue Type +	Ma	Location *	WS
Category	Earthen Levee			GPS Latitude/Longitude	
				Start	End
Item	Slope Stability			39.160285 °	39.160285 °
				-122.913481 °	-122.913481 °
DWR ID	DWR_NA0009_01_s _ 2013_13				
Comment Code					
S3 : Repair the levee slope damaged by vehicle traffic and prevent access where possible.					
Inspector Comment

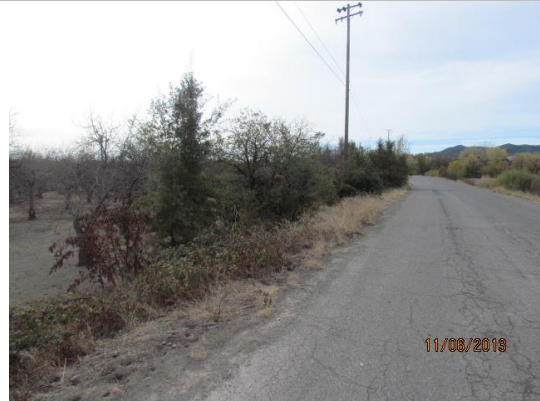
Photo 1 of 2 : SP\_2019\_NA0009\_3\_3\_20190411\_00001.jpg

LM Start	2.48	Rating **	U	Issue No.	3
LM End	2.55	Issue Type +	Ma	Location *	LS
Category	Earthen Levee			GPS Latitude/Longitude	
				Start	End
Item	Vegetation			39.161615 °	39.160804 °
				-122.911733 °	-122.912536 °
DWR ID	DWR_NA0009_01_s_2012_3				
Comment Code					
V2 : Remove the wild growth other than native grasses from the levee slopes.					
Inspector Comment					
The LMA cleared vegetation on the levee slope, but thick brush remains on the other side of the wire fence along the levee toe easement.

View of the vegetation along the landside slope.

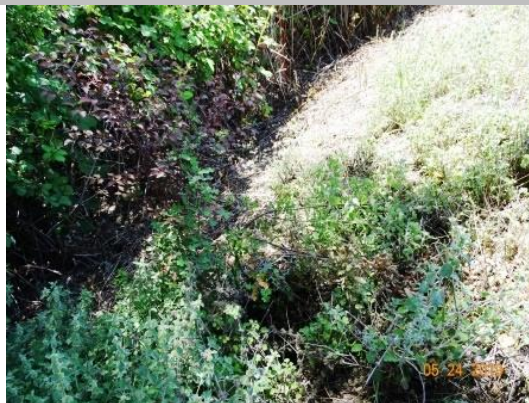
Photo 1 of 2 : SP\_2019\_NA0009\_3\_48\_20190524\_00040.jpg

View looking downstream at animal holes on the landside slope. Spring 2019

LM Start	2.49	Rating **	M	Issue No.	48
LM End	2.49	Issue Type +	Ma	Location *	WS
Category	Earthen Levee			GPS Latitude/Longitude	
				Start	End
Item	Animal Control			39.161472 °	39.161472 °
				-122.911822 °	-122.911822 °
DWR ID	DWR_NA0009_01_s_2019_48				
Comment Code					
A3 : No rodents visible, but rodent burrows visible; need to backfill and compact or grout burrows.					
Inspector Comment					
Backfill animal holes on both sides of the levee.

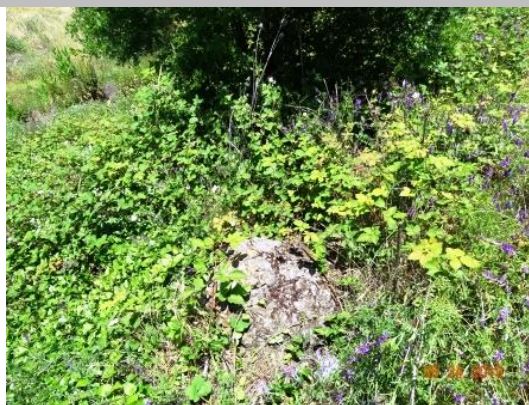
Photo 2 of 2 : SP\_2019\_NA0009\_3\_48\_20190524\_00041.jpg

View looking upstream at animal holes on the waterside slope. Spring 2019

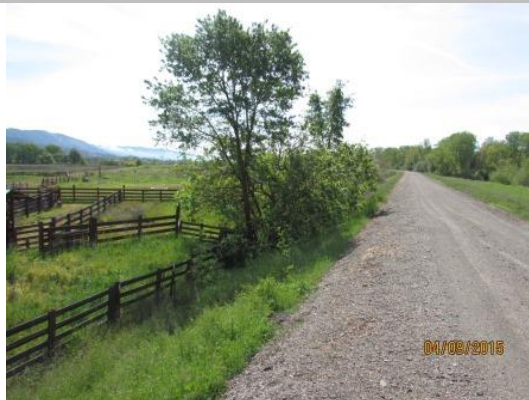
Photo 1 of 1 : SP\_2019\_NA0009\_3\_534\_20190411\_00017.jpg

LM Start	3.26	Rating **	M	Issue No.	534
LM End	3.30	Issue Type +	Ma	Location *	LS
Category	Earthen Levee			GPS Latitude/Longitude	
				Start	End
Item	Trim / Thin Trees			39.150957 °	39.150323 °
				-122.913504 °	-122.913155 °
DWR ID	DWR_NA0009_01_s_2015_534				
Comment Code					
T2 : Thin trees to allow visibility of the ground and room to flood fight.					
Inspector Comment

Remove the trees from the landside toe.

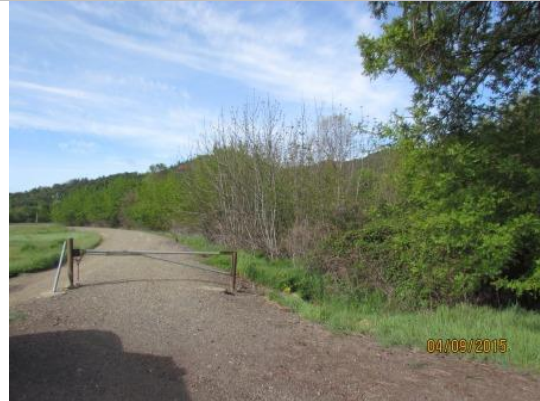
Photo 1 of 1 : SP\_2019\_NA0009\_4\_9\_20190411\_00005.jpg

View of the overgrown trees and vegetation at the landside toe.

LM Start	0.24	Rating **	M	Issue No.	9	
LM End	0.27	Issue Type +	Ma	Location *	LS	
Category	Earthen Levee			GPS Latitude/Longitude		
				Start		End
Item	Trim / Thin Trees			39.186739 °		39.186389 °
				-122.909436 °		-122.909821 °
DWR ID	DWR_NA0009_02_s_2013_9					
Comment Code						
T1 : Trim trees to at least five feet above ground level.						
Inspector Comment

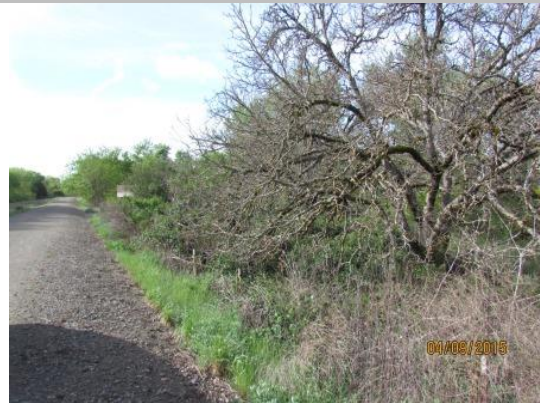
Photo 1 of 1 : SP\_2019\_NA0009\_4\_7\_20190411\_00004.jpg

View of the vegetation at the landside toe.

LM Start	0.97	Rating **	M	Issue No.	7
LM End	0.98	Issue Type +	Ma	Location *	LS
Category	Earthen Levee			GPS Latitude/Longitude	
				Start	End
Item	Vegetation			39.177218 °	39.176992 °
				-122.913673 °	-122.913642 °
DWR ID	DWR_NA0009_02_s_2012_7				
Comment Code					
V2 : Remove the wild growth other than native grasses from the levee slopes.					
Inspector Comment

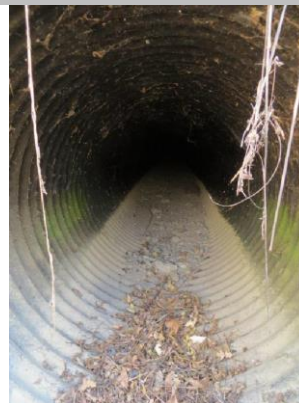
Photo 2 of 3 : UCIP\_SP\_2019\_27583\_51201.jpg

Pipe as visible from LS toe.

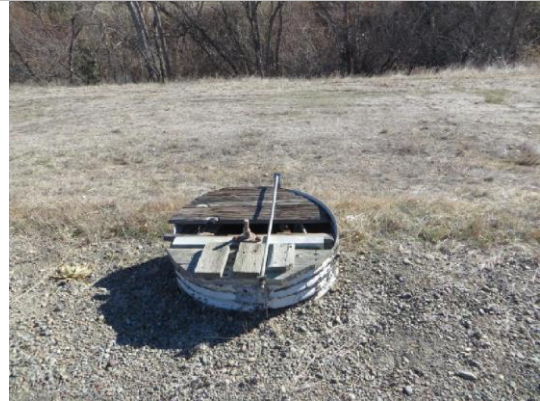
Photo 1 of 3 : UCIP\_SP\_2019\_42994\_51214.jpg

Slide gate in 44-inch CMP riser on WS shoulder.

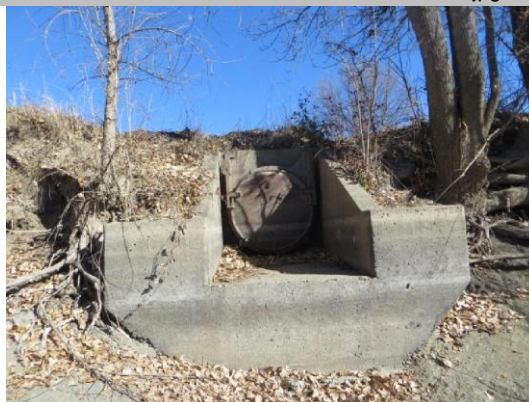
Photo 3 of 3 : UCIP\_SP\_2019\_27863\_51540.jpg

Concrete headwall and flapgate visible at WS berm.

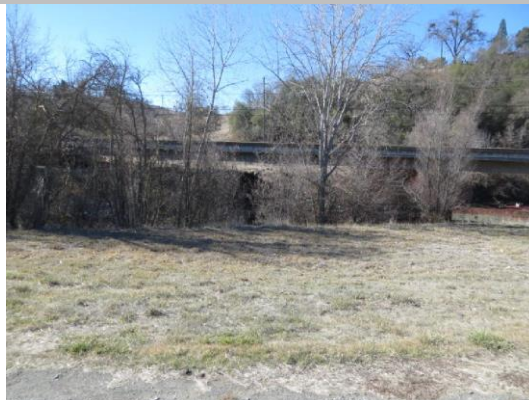
Photo 2 of 3 : UCIP\_SP\_2019\_27892\_51590.jpg

Concrete outfall visible off WS berm.

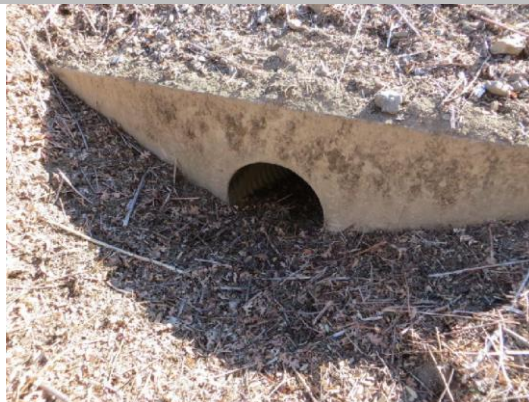
Photo 3 of 3 : UCIP\_SP\_2019\_27944\_51644.jpg

Concrete headwall on LS toe.

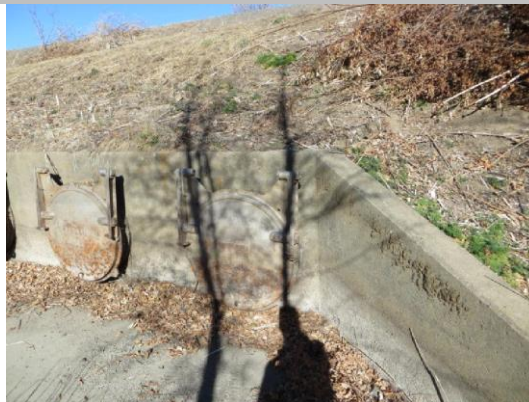
Photo 3 of 3 : UCIP\_SP\_2019\_27963\_51660.jpg

Flapgate on headwall at WS toe.

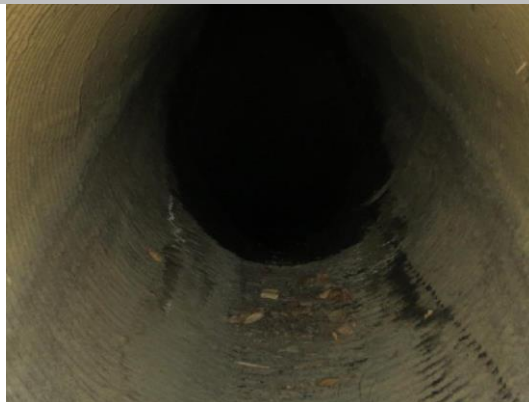
Photo 2 of 3 : UCIP\_SP\_2019\_27964\_51664.jpg

Pipe from LS toe.

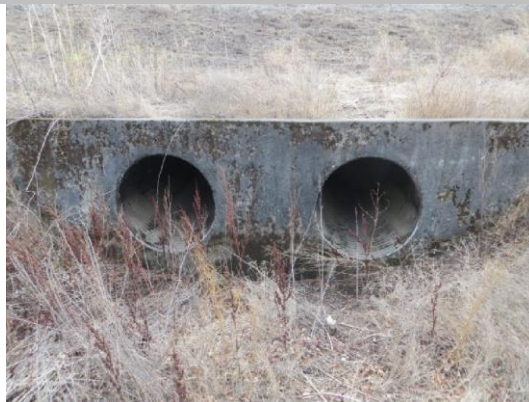
Photo 2 of 3 : UCIP\_SP\_2019\_26947\_49792.jpg

Concrete headwall visible on LS toe.

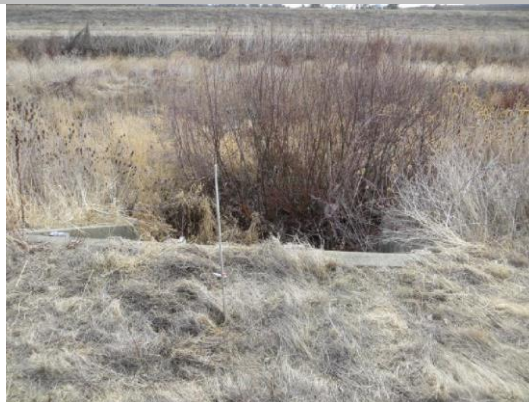
Photo 3 of 3 : UCIP\_SP\_2019\_26948\_49795.jpg

Concrete headwall visible on toe of WS berm.

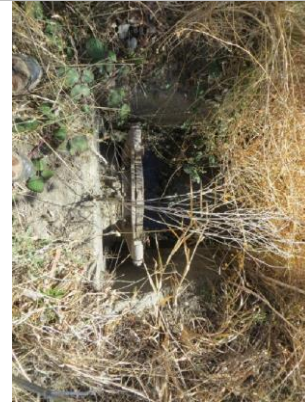
Photo 3 of 3 : UCIP\_SP\_2019\_53332\_49752.jpg

Comment Code						
Inspector Comment						
FS_ID:53332 DS_ID:21227 EP_NO: 11501 Repair Type: Urgent Crossing Status: Found UCIP Comments: 9/6/2018 Same as last inspection; crossing remains Urgent because of pipe integrity (D. Sanoski - DWR UCIP).11/30/2016 Clover Creek has significant sediment build up that blocks the outlet. Crossing is still in use to drain water from LS to WS according to LMA representative, Scott Webb. (O. Magana - DWR UCIP)01/09/2014 Pipe rusted through at connection to flapgate. Good indication pipe may need replacement. Video inspection recommended. (W. Wylie - DWR UCIP) FIELD_STRUCT_DESC: 24-inch corrugated metal (CM) drainage pipe through the levee, 13.8 feet below the crown. Flap gate is located on the waterside (WS) end. Concrete headwalls located on both the WS and landside (LS) ends. (24-inch pipe [HLM 0.77] was retained under Automatic Board Order (ABO) issued as Permit No. 11501, 1975 - Sisevich). [Additional Reference(s): DWR Levee Log, 2005. USACE Sacramento O&M Manual Unit 506.2, August 1961, (HLM 0.77)]. FS Date: 9/6/2018 3:49:00 PM

Flapgate at concrete headwall on WS toe.

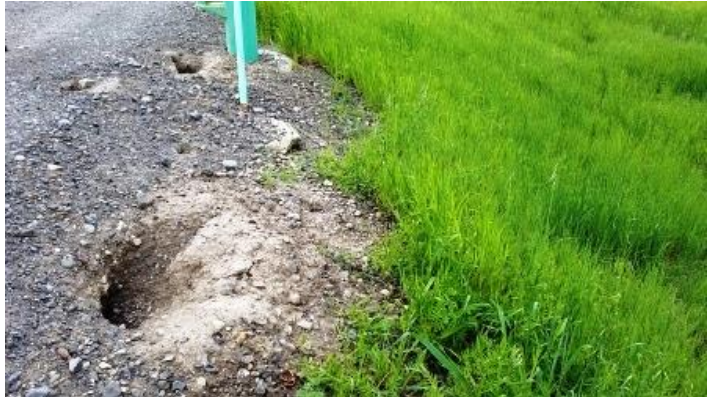
Photo 1 of 1 : SP\_2019\_NA0009\_6\_26\_20190415\_00024.jpg

View of rodent holes near the gate with animal activity. Spring 2019

LM Start	1.04	Rating **	M	Issue No.	26
LM End	1.04	Issue Type +	Ma	Location *	LS
Category	Earthen Levee			GPS Latitude/Longitude	
				Start	End
Item	Animal Control			39.180440 °	39.180440 °
				-122.896638 °	-122.896638 °
DWR ID	DWR_NA0009_04_s _ 2019_26				
Comment Code					
A1 : Exterminate rodents and backfill and compact or grout burrows.					
Inspector Comment

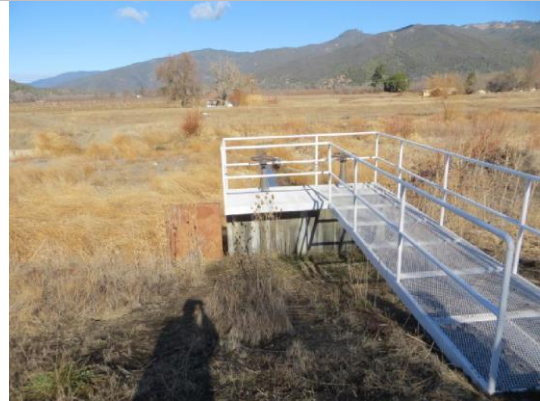
Photo 1 of 3 : UCIP\_SP\_2019\_26891\_49682.jpg

Slide gate on steel walkway at WS toe.

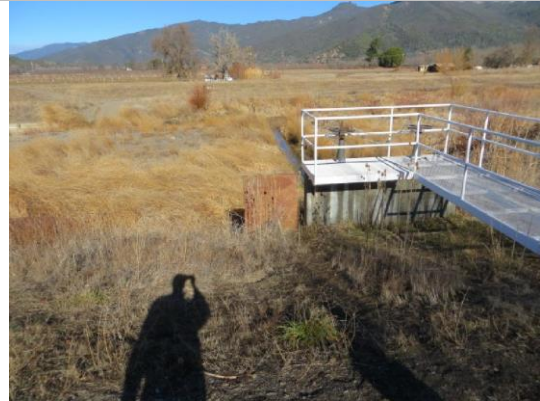
Photo 1 of 3 : UCIP\_SP\_2019\_26888\_49666.jpg

Steel slide gate visible at concrete headwall on WS toe.

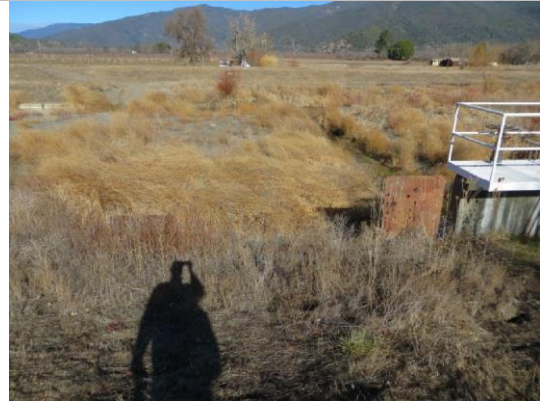
Photo 1 of 3 : UCIP\_SP\_2019\_26883\_49622.jpg

Comment Code					
Inspector Comment					
FS_ID:26883 DS_ID:21231 EP_NO: 11507 Repair Type: Non-Urgent Crossing Status: Found UCIP Comments: 10/27/2017 This structure is inspected annually under the Structure and Channel Summer Inspection (part of the Levee Inspection Program) conducted by the DWR Flood Project Integrity and Inspection Branch (FPIIB). (DWR UCIP - O. Magana) Some sediment buildup on LS toe. FIELD_STRUCT_DESC: [Clover Creek Diversion Structure] 5 of 6: 36-inch corrugated metal drainage pipe through the levee, 12 feet below the crown. Concrete headwall on both ends. Steel slide gate blocks inlet on the waterside (WS) toe. (six 36-inch pipes and structure [HLM 0.3] retained under Automatic Board Order (ABO) issued as Permit No. 11507, 1975 - Lake County Flood Control and Water Conservation District). [Additional Reference(s): DWR Levee Log, 2005. USACE Sacramento O&M Manual 506, Part 2, August 1961, (HLM 0.31)]. FS Date: 1/9/2014

Metal slide gate visible at concrete headwall on WS toe.

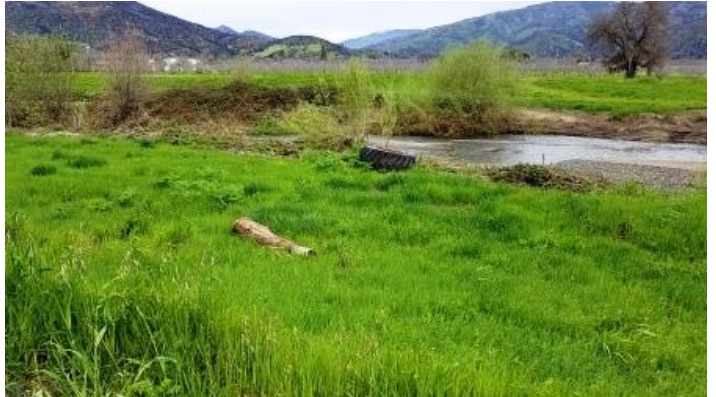
Photo 1 of 1 : SP\_2019\_NA0009\_7\_17\_20190415\_00029.jpg

LM Start	0.33	Rating **	M	Issue No.	17
LM End	0.33	Issue Type +	Ma	Location *	WS
Category	Earthen Levee			GPS Latitude/Longitude	
				Start	End
Item	Encroachments			39.176973 °	39.176973 °
				-122.899228 °	-122.899228 °
DWR ID	DWR_NA0009_05_s _ 2019_17				
Comment Code					
DE : Debris					
Inspector Comment					
Remove tree log and large tire in the waterway.

View of large tire and tree log in the waterway. Spring 2019

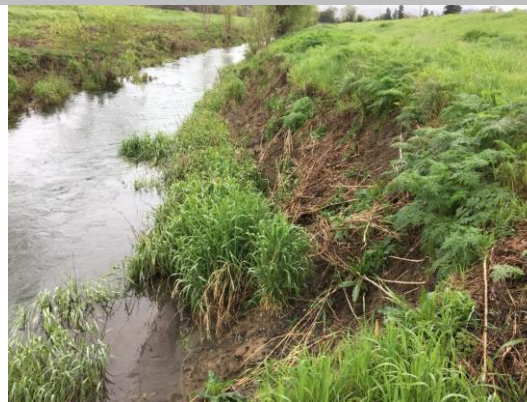
Photo 2 of 4 : LEVAL\_SP\_2019\_20\_340.jpg

LM Start	0.82	Rating **	M	Issue No.	20
LM End	0.86	Issue Type +	Ma	Location *	WS
Category	Supplemental			GPS Latitude/Longitude	
				Start	End
Item	2017 Storm Damage			39.175740 °	39.175750 °
				-122.907980 °	-122.908710 °
DWR ID	DWR_NA0009_05_f_2017_20				
Comment Code					
Inspector Comment					
Levee Evaluation Comments					
Description:					
Site ID No:20					
Site Designation:LCWPD-02					
Repair Type: Erosion					
Rating:Area of Concern					
Field Date:6/5/2017					
Notes: 5 - 7 ft deep erosion scarps, bank is normally near vertical but at a much smaller drop off, 1 - 3 ft. Spring 2019 DWR Inspection: New erosion widened the creek downstream.

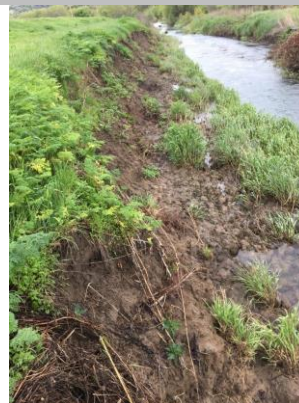
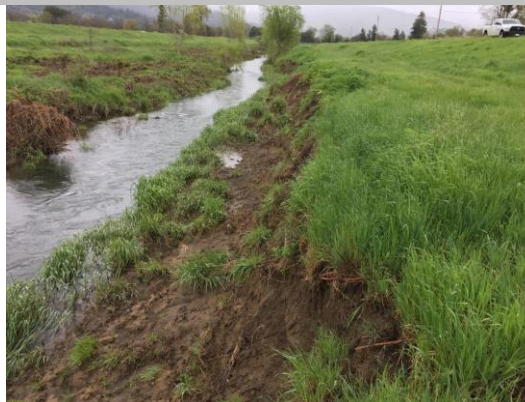
LM Start	0.82	Rating **	M	Issue No.	20 (cont)
LM End	0.86	Issue Type +	Ma	Location *	WS
Category	Supplemental			GPS Latitude/Longitude	
				Start	End
Item	2017 Storm Damage			39.175740 °	39.175750 °
				-122.907980 °	-122.908710 °
DWR ID	DWR_NA0009_05_f_2017_20				
Comment Code					
Inspector Comment					
Levee Evaluation Comments					
Description:					
Site ID No:20					
Site Designation:LCWPD-02					
Repair Type: Erosion					
Rating:Area of Concern					
Field Date:6/5/2017					
Notes: 5 - 7 ft deep erosion scarps, bank is normally near vertical but at a much smaller drop off, 1 - 3 ft. Spring 2019 DWR Inspection: New erosion widened the creek downstream.
